Thermal fatigue response of W-EUROFER brazed joints by the application of High Heat Flux loads

I. Izaguirre^{a,*}, T. Loewenhoff^b, J. de Prado^a, M. Sánchez^a, M. Wirtz^b, V. Díaz-Mena^a, A. Ureña^a

ABSTRACT

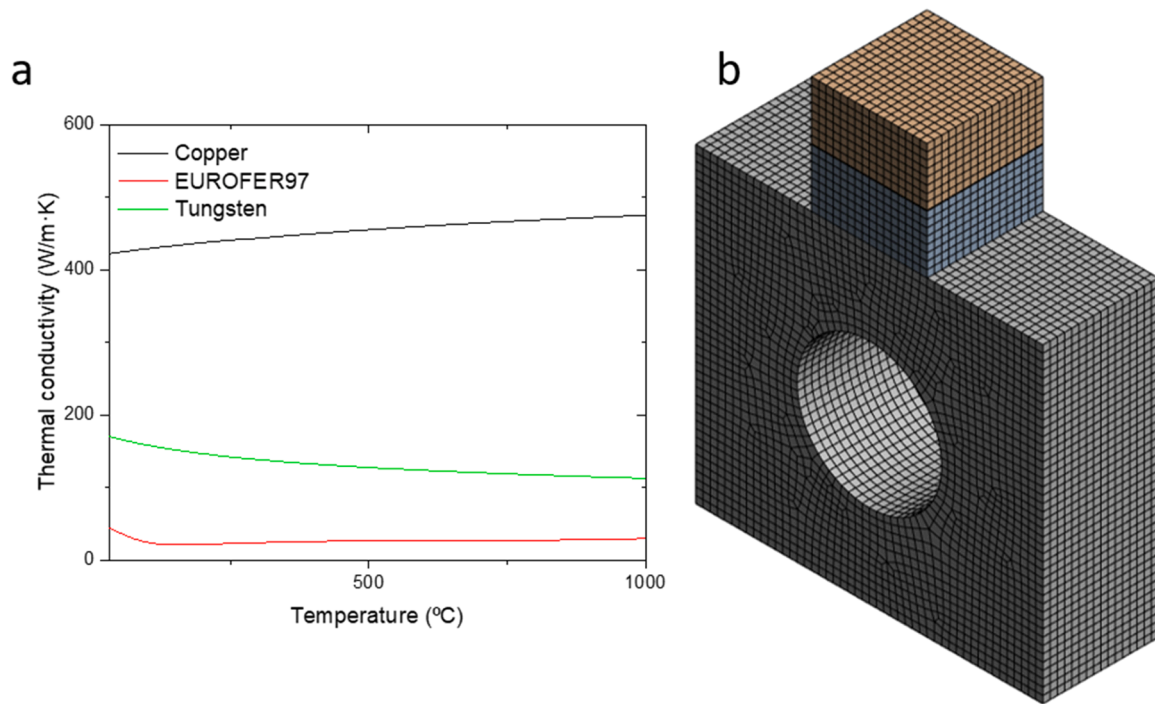
Fig. 2. a) Thermal conductivity used for the FEM simulation of HHF tests. b) Example of the mesh distribution developed for the FEM simulation.

The distribution of temperature across the joint and in the braze joint was calculated by Finite Element Modeling (FEM) simulation with ANSYS software using the material data described at the beginning of Section 2. A schematic of the samples brazed to the cooling structure used in the simulation is shown in Fig. 2, where the mesh used to calculate the different parameters are also shown. Boundary conditions applied for the FEM simulation are: 1) Eurofer surface temperature in contact with the copper cooling structure was set to 25 °C, which is the temperature of the cooling fluid used. 2) Exposed tungsten surface to the electron flux was set to 600, 700 and 800 °C temperature. 3) The thermal conductivity used for the FEM simulations are represented in Fig. 2a. The data were collected from the following sources Lassner and Schubert (1999); Linsmeier et al. (2017); Rieth et al. (2003), where they studied the physical, thermal and mechanical properties of copper, tungsten and EUROFER materials with temperature. Fig. 2c shows the mesh distribution developed for the FEM simulation.

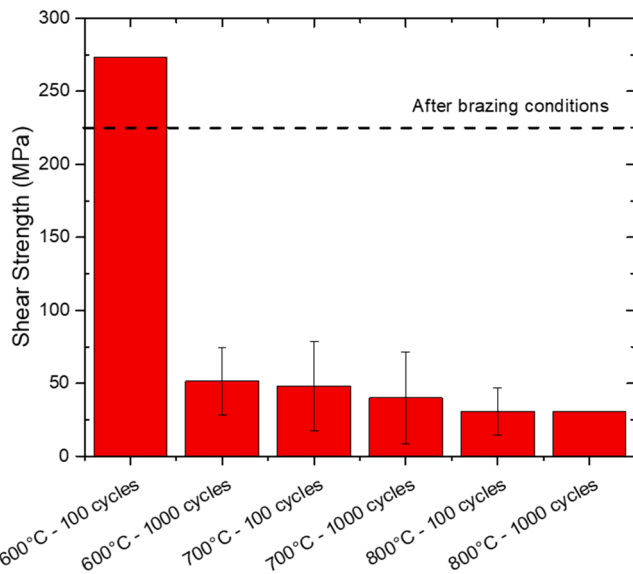
Fig. 11. Shear strength of W-EUROFER joints subjected to different HHF conditions of W surface temperature and number of cycles.

The shear strength of the joints is shown in Fig. 11. The shear strength of the sample tested at 600/498 °C, 2 MW/m² and 100 cycles is around 275 MPa, in this case only one sample survived to this condition, the other were examined by SEM to study the failure mechanisms, as

was previously discussed. Only one sample could be tested because the other two were removed from the cooling structure during the cycling test. The shear strength dropped down to 50 MPa after 1000 cycles. This value is lower than that reported for joints at as-brazing conditions (225 MPa) because of the formation of cracks at the edges of the joint between the Cu band and the Fe rich region. This effect was intensified as the W surface temperature and the number of cycles was increased. It was an expected behavior since the temperature gradient between the hot W surface and the cooling copper structure increases with the surface temperature and, therefore, the stresses generated by the mismatch of the CTE also do. These stresses are generated and accumulated in each cycle generating residual stresses and cracks that contribute to the reduction of the strength of the joint.

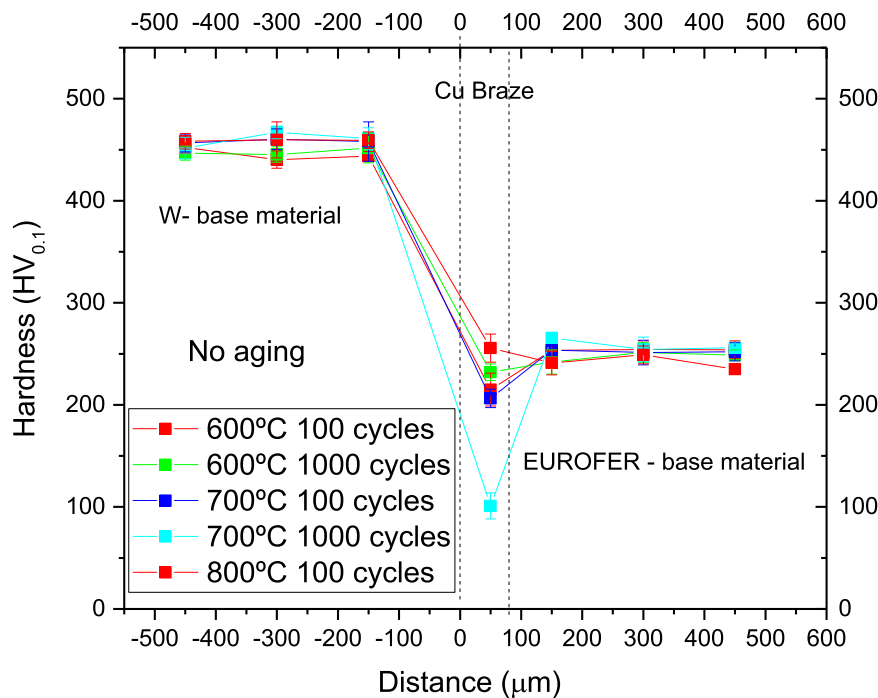
Fig. 14. Vickers microhardness profiles of W-EUROFER joints for the different HHF test conditions.

To evaluate the thermal effects on the base materials caused by the HHF tests, microhardness profiles were traced from one base material to the other through the braze. The results indicated that microhardness of both base materials was not affected neither by the aging process nor by the HHF tests (Fig. 14). In the case of tungsten, microhardness kept constant for all conditions and corresponded to the hardness of base material in as-received conditions (440 HV_{0.1}) (Kim et al., 2021).
