Measurement of Thermal and Electrical Parameters in Photovoltaic Systems for Predictive and Cross-Correlated Monitorization

Abstract: Photovoltaic electricity generation is growing at an almost exponential rate worldwide, reaching 400 GW_p of installed capacity in 2018. Different types of installations, ranging from small building integrated systems to large plants, require different maintenance strategies, including strategies for monitorization and data processing. In this article, we present three case studies at different scales (from hundreds of W_p to a 2.1 MW_p plant), where automated parameter monitorization and data analysis has been carried out, aiming to detect failures and provide recommendations for optimum maintenance procedures. For larger systems, the data collected by the inverters provides the best source of information, and the cross-correlated analysis which uses these data is the best strategy to detect failures in module strings and failures in the inverters themselves (an average of 32.2% of inverters with failures was found after ten years of operation). In regards to determining which module is failing, the analysis of thermographic images is reliable and

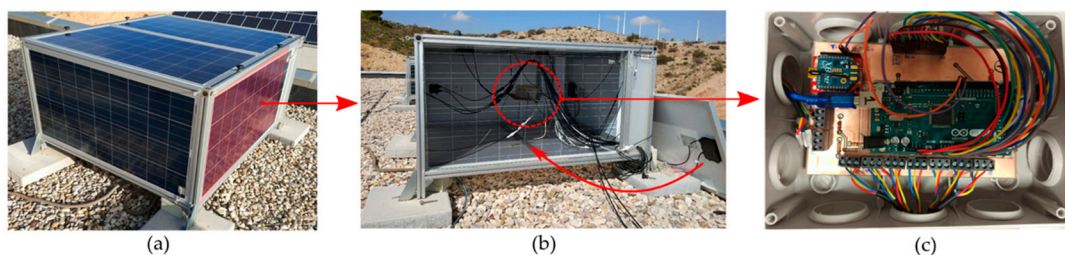
Figure 1. (a) c-Si PVCube installed on the rooftop of one of the buildings at the University of Murcia. Orientation of each face is south, north, west, east and horizontal (top). (b) Inside of the c-Si PV-cube: Temperature sensors are attached to the back and frontside of each photovoltaic (PV) module. Additionally, in the centre, temperature and humidity sensors are installed. (c) Data logger system: Arduino and Xbee transmitter, both installed inside of the PVCube.

Thermal monitorization of the c-Si PVCube’s different faces provides information about the module temperature. In this case of study, the module orientations were: Vertical inclination (90°) with different azimuth (east, west and south) and horizontal (0°), but the methodology can be applied to any orientation (which is especially useful for BIPV systems).

The BIPV test facility was located at 38°01’24’’ N and 1°10’32’’ W, on the roof of one of the 12 m high buildings at the University of Murcia (Spain), and it collects the temperature of each face (inner and outer), together with the temperature inside the cube, in order to monitor the thermal evolution during the day and night. These data are complemented with environment data (global and diffuse irradiance for horizontal plane, wind speed and direction at a 2 m elevation from the roof, ambient temperature and humidity) measured with a weather station and a pyranometer located very close to the facility. The facility has been in operation since July 2017, with a sampling rate of five minutes. It has been running continuously since then, thus providing an extensive database for detailed analysis. Determination of the electrical parameters (I-V characterization) was carried out using an I-V tracer. Details about the monitoring system, data collection and analysis are provided below.

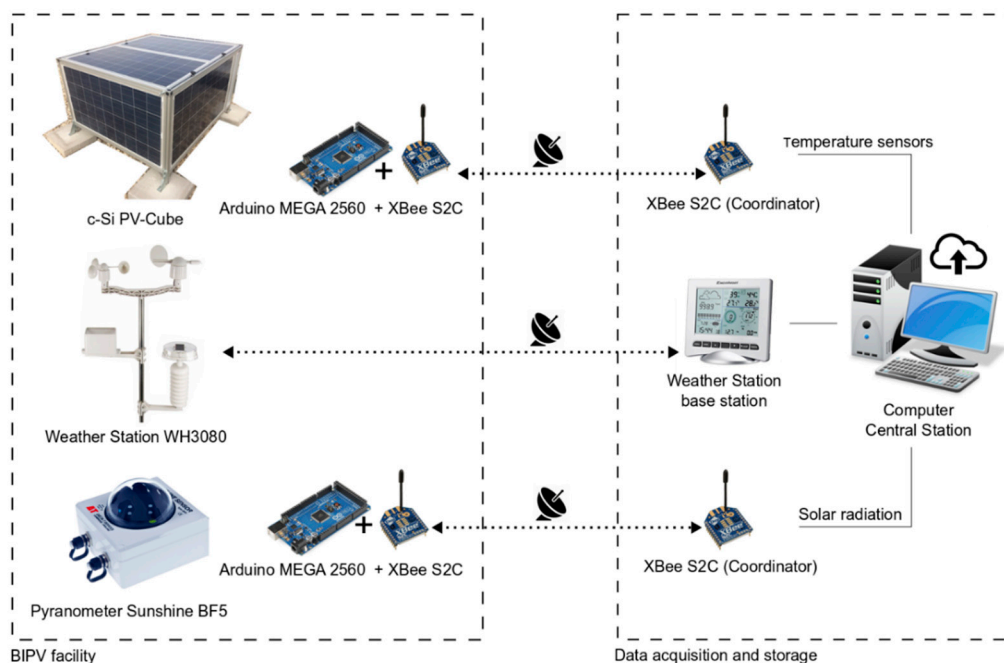
Figure 2. Basic architecture of the monitoring system using a wireless sensor network with the ZigBee protocol for the building-integrated photovoltaic (BIPV) “PVCube” facility (rooftop), which radio-transmits data to a laboratory in the lower floor.

Irradiance has been measured using a single sensor in the horizontal position and then the irradiance for different orientations has been calculated. The irradiance measurement and calculations were compared with the data provided by the photovoltaic geographical information system (PVGIS) [28] for the same location. Since the solar radiation data is measured on a horizontal plane, the estimation of the incident irradiance for the other surfaces of interest is based on applying Muneer's method [29]. The model distinguishes between clear and overcast sky conditions and sunlit and shaded surfaces, and it is one of the most used anisotropic irradiance models implemented in recognized databases such as the PVGIS. The global irradiance provided by the pyranometer and its diffuse and beam components, respectively, was used as the input data. The reflected irradiance was assumed as isotropic, considering the value of 0.2 for the ground's albedo (gravel roof). The accuracy and range of each of the measured parameters is detailed in Table 1. The system's basic architecture is shown in Figure 2.

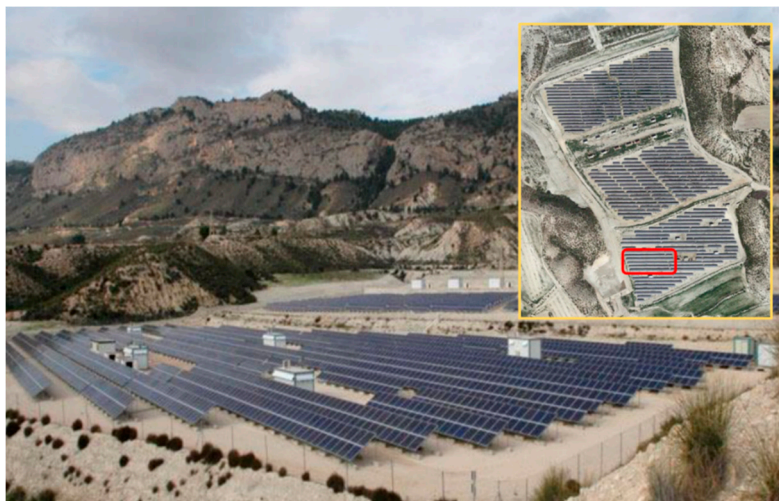
Figure 3. The 2.12 MW_p Yéchar photovoltaic plant (Murcia), in the inset the sector of modules which have been monitored using thermographic camera is shown.

The inspection by thermal camera was carried out manually on a sector of the plant comprising 245 modules (PW1650, 165 W_p). The inspected sector, indicated by a red rectangle in the inset of Figure 3, is shown alongside a picture of the plant. The inspection was carried out in 2017, eleven years after the installation of the modules. A thermocamera was used to take individual pictures of each module. The camera was a FLIR TAU2 model with a resolution of 640 × 512 pixels (pixel pitch 17 μm), a sensitivity of <30 mK, a spectral band of 7.5–13.5 μm, a scene range (high gain) of −25–100 °C and a scene range (low gain) of −40–550 °C, providing enough resolution and accuracy to detect temperature gradients within individual solar cells. The “Flir Tools” software was used for the image analysis. All of the thermographic pictures were taken with irradiance levels higher than 800 W·m^{−2}, and the camera was calibrated and the emissivity factor was determined by random sampling of several modules, providing a value $\epsilon = 0.75$, which was used to assign temperature values to all of the thermographic images.

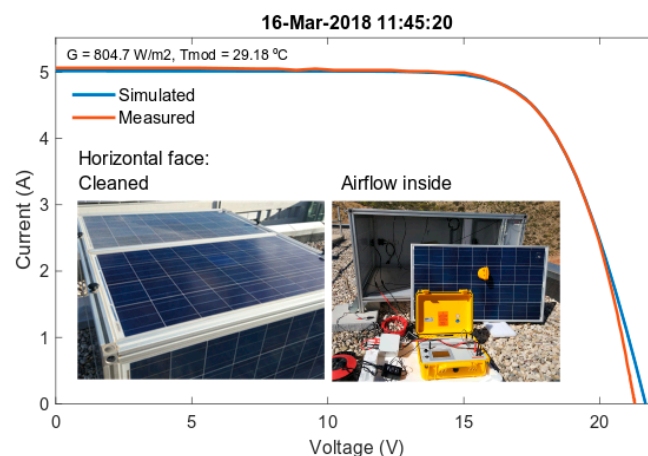
Figure 4. Measured and simulated I-V curve for the horizontal face when the PV module was cleaned and one face was opened, allowing airflow inside of the structure. The measured I-V curve was obtained by the I-V tracer PVPM 1000CX. The simulated curve, solving the single-diode equation through toolbox, was developed by Sandia National Laboratories, using a PVSyst model and setting as inputs the in-plane irradiance, module temperature, and specifications given by the PV module manufacturer at standard test conditions. Further details about the toolbox and modeling functions can be found in [30,31].

Regarding the c-Si PVCube, Figure 4 shows an example for the measured and simulated I-V curves for the horizontal face of the cube when the PV module was cleaned and one face was opened, allowing airflow inside of the structure. There was a slight lost in the experimental Voc (+1.8%), likely caused by measurement error. The behavior of the cube when there is not airflow inside (all the faces closed, fully integrated) presents a dramatic increase in module temperature, and consequently the thermal stress of the structure, which is correlated with the in-plane irradiance. Figure 5 shows an example of the thermal and ambient parameters, monitored for 48 h, which were used to analyze the thermal evolution on the inner horizontal module and its dependence on ambient conditions, such as irradiance, ambient temperature, relative humidity and wind speed. Two typical days are shown: Clear and cloudy. In this case, the difference between the ambient and module temperature during night time is close to 5 °C, but during daytime, the module temperature differs up to 20 °C compared to ambient temperature, when the received irradiance has a value close to 800 W·m⁻².

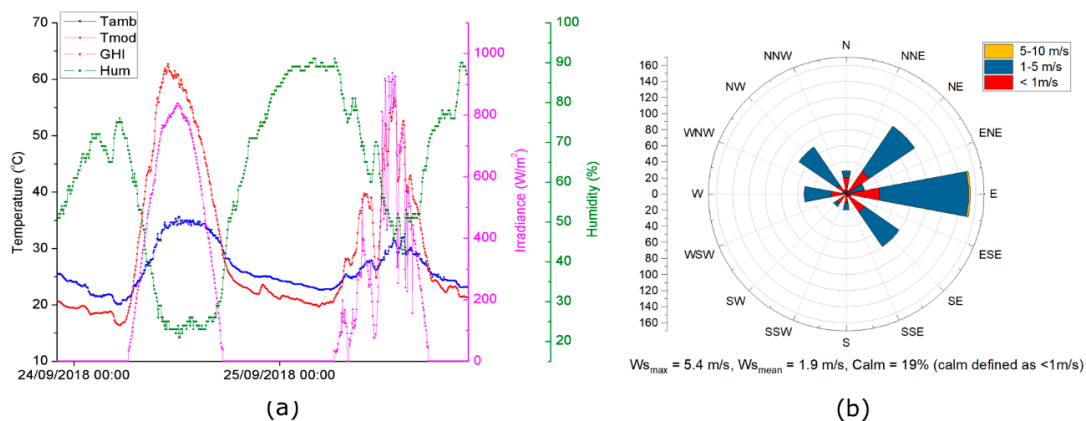
Figure 5. Ambient and thermal parameters during summer time, covering two characteristic days: Clear and cloudy (from 23/09/2108 22:00 to 25/09/2018 22:00, GMT 0, $n = 617$). (a) Thermal evolution of the module (T_{mod}) located at horizontal face compared to ambient temperature (T_{amb}), global horizontal irradiance (GHI) and relative humidity (Hum). (b) Wind speed distribution with details about the maximum ($W_{s_{max}}$) and average ($W_{s_{mean}}$) wind speed.

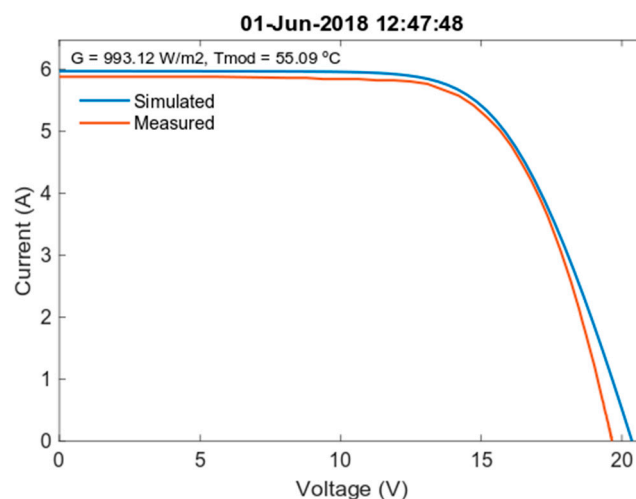
Figure 6. Measured and simulated I-V curves for the horizontal surface when the PV module is fully integrated after two days of rainfall. A small reduction of photocurrent is detected when compared to the model (and to the just-cleaned module).

Figure 6 shows the measured and simulated I-V curves for the horizontal surface when the PV module is fully integrated (there is no airflow inside the PVCube) after two days of rainfall. The DC power output that was measured had a deviation of -1.7% from the reference value. Despite the difference between the model and predicted output not being considerable, since the system has been working for about 15 months, slight differences from the reference model can provide information about potential faults in the system and degradation processes. For instance, the slightly lower short-circuit current is likely caused by the dust, which blocks irradiation. This information can be relevant in the establishment of the corrective maintenance, defining a threshold where actions are required. On the other hand, the evident reduction of the open circuit voltage as a result of a short circuit fault is likely caused by thermal stress (high working temperatures and poor air ventilation), which affects the junction box and therefore the bypass diodes. This behavior for BIPV systems has previously been reported by Spertino et al. [33].

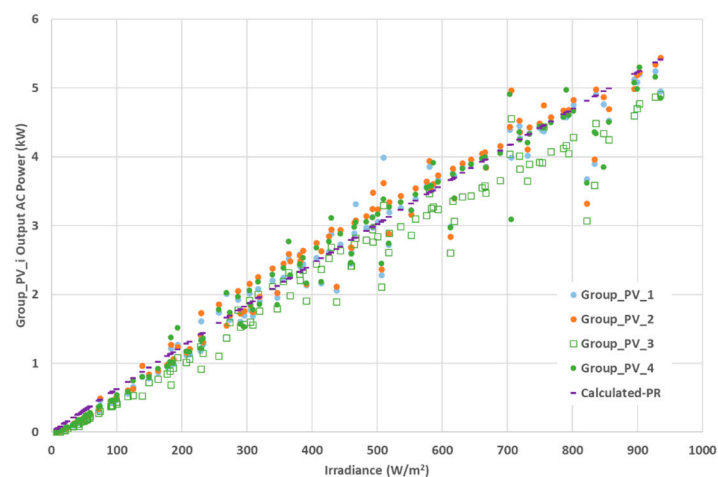
Figure 7. Calculation of the expected AC output power of a group of inverters in the CdTe PV parking garage system (purple bars) as a function of measured irradiance for a whole day. Experimental output values of different strings are also presented (circles), one of them clearly underperforming (Group 4, open green squares).

a given irradiance and temperature (which are measured) using the manufacturer technical parameters. Detection of faulty “strings” can be obtained, since the power output is aggregated by the inverter for each string of modules. A set of calculated and measured maximum power points is presented in Figure 7 (purple bars). For strings that are working correctly, the difference is small, while for faulty strings, the comparison of both values easily provides an “alert”, indicating that this particular string is failing (open green squares in Figure 7). The detection of the exact module (or modules) which is (are) failing in this case will require special measurement of individual modules, which is a manual maintenance procedure once the faulty string has been automatically detected.

It can also be appreciated that the modelling based on a performance ratio which depends on irradiance and temperature is correct, but in this case, it has considered a single constant value for the efficiency of the AC inverter (“European” efficiency) while the real curves for the inverter efficiency show a drop in its value for lower outputs of converted AC power. This is the reason why the modelling is more accurate for higher irradiances (and therefore power conversion closer to the nominal maximum power of the inverter) and shows an overcalculation for irradiances lower than $250 \text{ W}\cdot\text{m}^{-2}$.

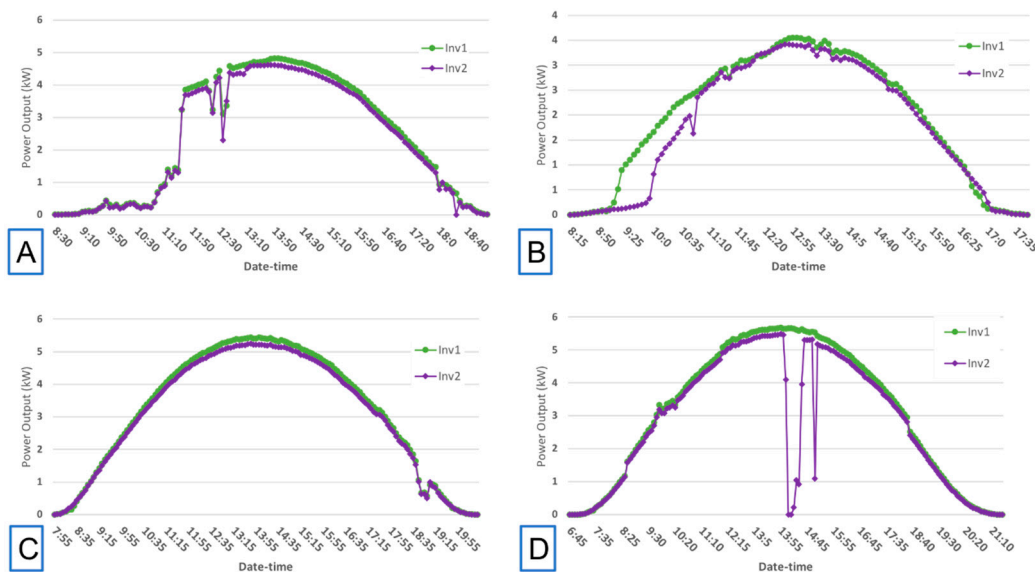
Figure 8. Power output of two groups of modules with same nominal power and same location. Four days are shown from different season: (A) October, (B) December, (C) April and (D) June.

From the stored datasets, there are chances to identify real time performance faults or inefficiencies without the use of environmental data or solar cell modelling. Figure 8 shows the power output of two different PV modules groups which are technically identical and are simultaneously measured

under the same environmental conditions (irradiance, temperature and wind). It is already obvious that one of the strings is underperforming, but also instantaneous faults can be easily detected, as can be seen in the loss of power output in Figure 8D for one of the inverters. Single faulty events can be undetected unless an automated alarm is triggered in the inverter, and only a data treatment of a larger time span enables reliable failure detection. Furthermore, in Figure 9, the cross-correlation of the string’s power output provides a fast and clear method to detect failing strings. This procedure does not require any kind of modelling and simple algorithms can be applied to cross-correlate all strings with other strings or the mean value of all strings (ideally excluding the one being compared). The lower power generation shown in Figures 8 and 9 for the behavior of Inv2 could indicate the shade effect, the soiling effect, or the mismatching effect in the solar array, for example.

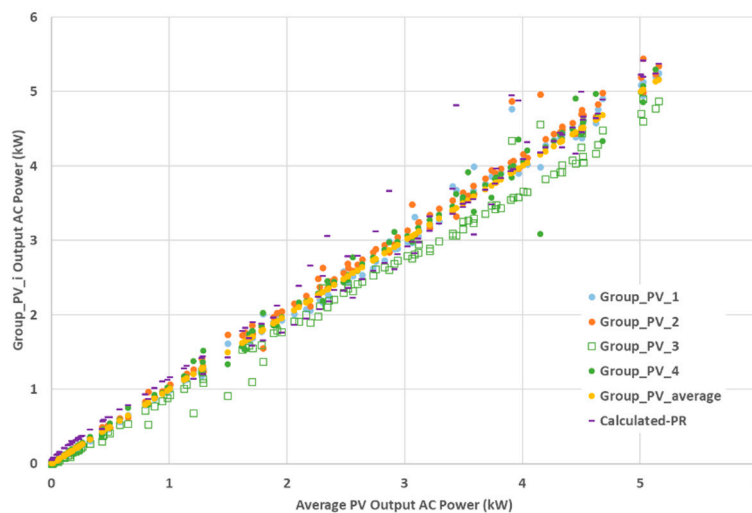
Figure 9. Cross-correlation between the power output of a group of modules (one inverter per string) and the average value of several groups. The four groups are technically identical (same nominal power installed, location and tilt) and are operating in the same conditions (real time). The cross-correlation can easily identify a faulty string (in green squares).

This method of cross-correlation for a massive amount of data is very reliable, as can be seen in Figure 9, where the faulty string (Group 4, green open squares) is showing a strong underperformance when compared with the other groups or the average value of several groups at all output powers. This kind of failure is not detected automatically by the single inverter, since the group is behaving correctly. The theoretical output presented in the previous section is also superimposed in Figure 9, to show how the identification of the faulty string is clearer with the cross-correlation than the modelling (as shown by comparing Figures 8 and 9) due to the uncertainty in the technical parameters and the measurement of the environmental magnitudes used for the model calculation.

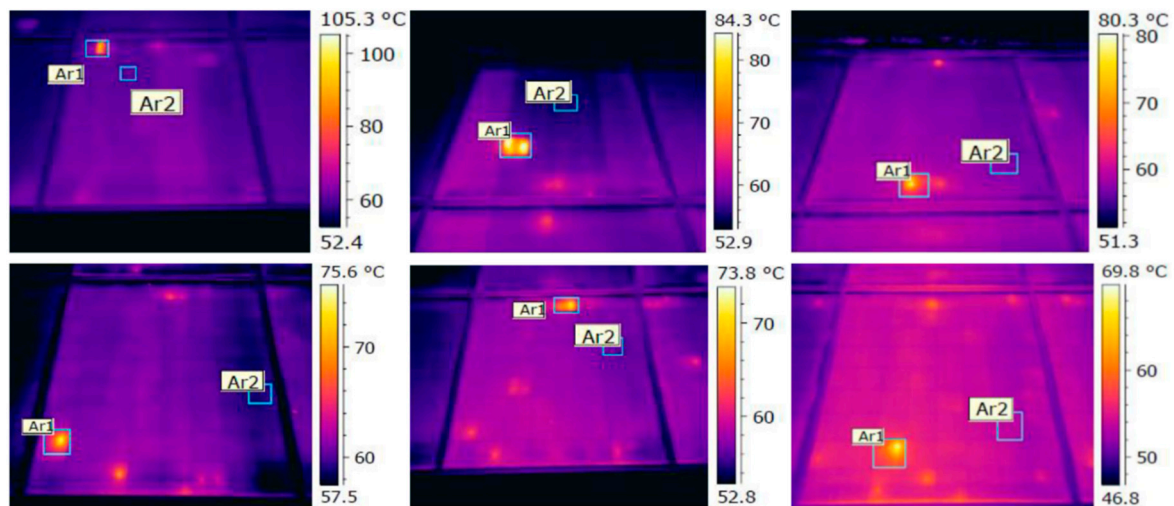
Figure 10. Thermographs of six selected modules, all of which presented grave or medium failures. The areas whose temperatures were compared are shown in the pictures and labelled as Ar1 (for anomaly) and Ar2 (for background).

In Figure 10, thermographs of six panels in which failures were detected by temperature gradients are shown. Two areas are indicated in each picture: One containing the highest temperature (Ar1) and other containing a medium-low temperature area (Ar2). The maximum temperature within each area was compared and a gradient was obtained and used to classify the failures. Only six representative images showing clearly the presence of overheating are shown here. A total of 245 thermographs were obtained, with 66 of them showing a ΔT larger than 5 °C.

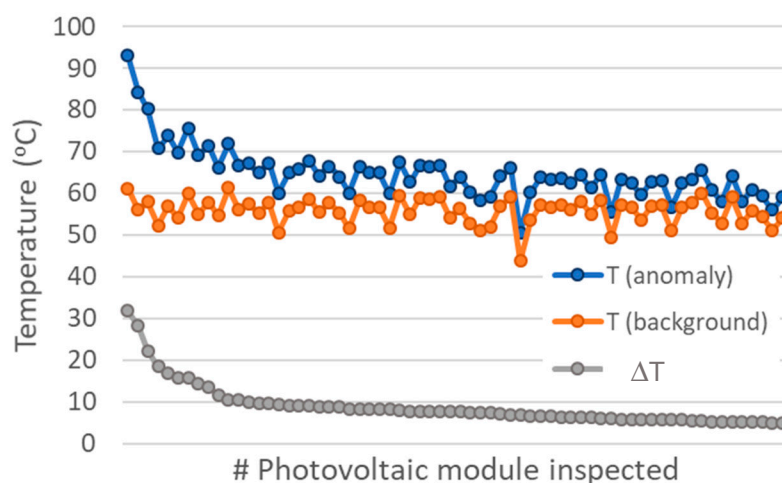
Figure 11. Temperatures measured with the thermocamera in selected areas of the modules: Area considered an anomaly (Ar1) is indicated by blue points, area considered background (Ar2) by orange points and the difference between them by grey points.

Figures 11 and 12 show the distribution of temperatures between the anomaly and background areas of all 66 modules which can be considered as failures according to the criteria explained in the methodology section. In Figure 11, the distribution of temperatures is shown (ordered by the amount of ΔT , from higher to lower, left to right), with only a few modules showing temperatures above 70 °C. All of them have a very large ΔT (grave or medium fault). In Figure 12, a cross-correlated plot is presented, and the distribution of failures can be easily identified by the superimposed lines marking ΔT in excess of 5 °C, 15 °C and 30 °C, respectively. A certain correlation is shown which relates the higher range in module temperature with higher ΔT , but it cannot be considered a consolidated trend due to the dispersion of the data. All modules inspected with $\Delta T < 5$ °C will be in the grey striped area. Once the modules with grave and medium failures were detected, visual inspection of the modules indicated that the grave failure were due to a fractured cell, the medium failures also included a fractured cell, but all others failed due to failure of the welding of string contacts within the module. In the remaining 59 light failures, all but four were string welding problems, the four remaining being a problem with the connection box between modules (three cases) and a possible problem with the bypass diode (one case).

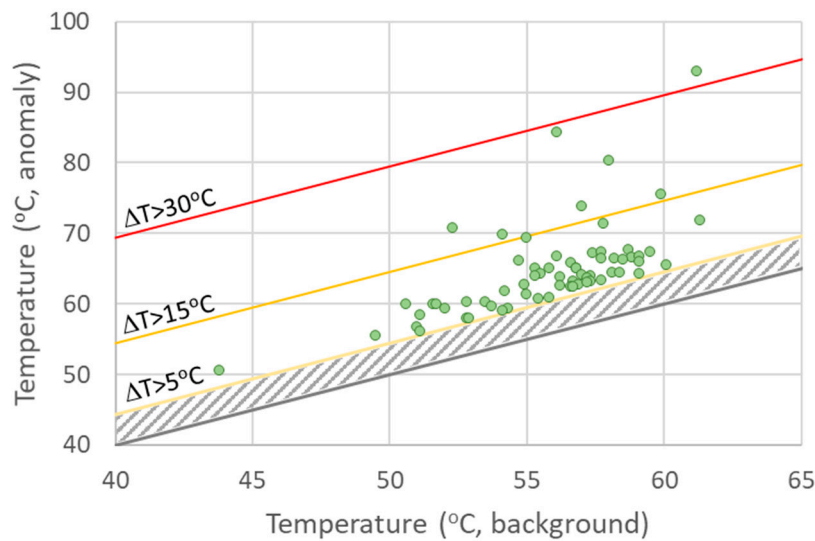
Figure 12. Cross-correlation of anomaly and background temperatures for each module (which are represented by a single green point). The points located within the yellow bands indicate light and medium failures, those points above the red line indicate a grave failure. The grey striped area is considered normal operation.

As a conclusion, and apart from the broken cells (only two), it can be said that all failures were due to problems in the soldering of string contacts within the modules. A replacement of the seven modules with grave and medium failures (53 and 316, respectively, if we extrapolate to the whole plant) will be a quick and easy maintenance procedure that will improve the performance ratio of the solar plant. In this case, a more automated procedure to locate the failing modules in the whole plant should be developed, since a manual procedure cannot be applied easily at very large scale, as commented in the discussion section.

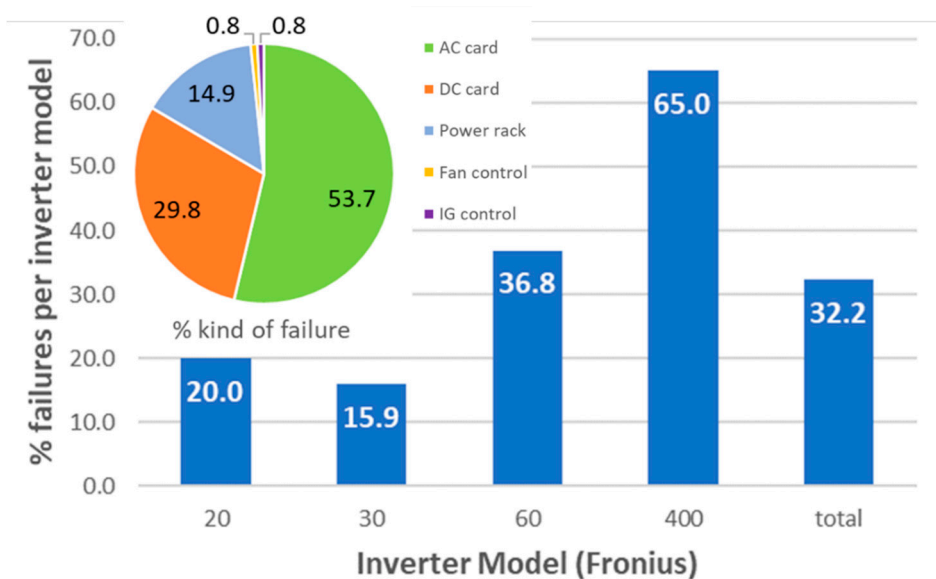
Figure 13. Percentage of inverters of each Fronius model with failures (after ten years of operation) in 99 sectors, with a total of 279 inverters in the Yéchar Solar plant. The inset pie chart shows the share of every kind of failure.

Finally, and also focused on the Yéchar solar plant, the failures detected in the Fronius inverters are summarized in Figure 13. The number of failures was high after ten years of operation, providing an average of 32.2% between all models, with a special incidence of high power inverters (65%, with failures in the power stage). The number of inverters inspected was high (279), providing significance to the statistical values, especially for models 30 and 60, which were the most used. All of the inverters have been working in the same environmental conditions, and therefore this sample is very useful to test the reliability of models from the same manufacturer. From this study, it is clear that smaller inverters are more reliable. The distribution of failures is included as a pie chart inset in Figure 13. The AC card (53%) and DC card (29.8%) failures (percentages over total number of failures detected) are the parts which required more reparations, followed by the power racks (14.9%, over total, but with special incidence in the largest model 400 inverters, as can also be seen from the 65% of them which failed). Reparation of the inverters requires manual operation and it is therefore expensive. Preventive detection for this kind of failure will require analysis of trends of power output and machine learning procedures to provide alert signals before the actual failure occurs.

If the failure is within the inverter, then the damaged component must be replaced (for example AC or DC cards, which are the main failed component in the monitored Fronius set of inverters in the solar plant, see Figure 13). The cost of this replacement is always high, and most of the time, the component has to be sent to the manufacturer, and in this case, also the cost of opportunity arising from having the inverter offline for several weeks has to be added to the repair cost (for the mentioned cards, around 800 euros per unit, information from company “CRES” (“Compañía Regional de Energía Solar” (CRES), Avenida Libertad 213, San José de la Vega, 30570 Murcia, Spain). The cost of opportunity is larger for larger inverters. In the case study of the solar plant, the larger inverters also presented a higher statistical number of failures (reaching 65% in ten years), and therefore, the main
